SUMMARY
 1234 Main Street Belmont NC 28012
 Buyer Name
 10/08/2022 9:00AM

David Laws
 Internachi Certified Professional
 Inspector
 Laws Home Inspections LLC
 980-484-8152
david@lawshomeinspections.com

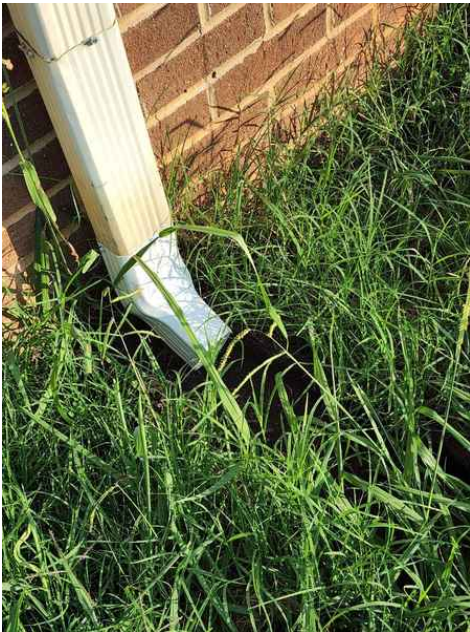
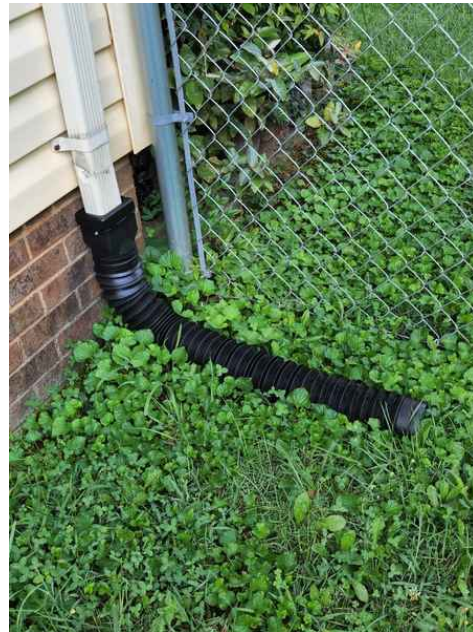
2.2.1 Roof Drainage Systems

DOWNSPOUTS DRAIN NEAR HOUSE

One or more downspouts drain too close to the home's foundation. This can result in excessive moisture in the soil at the foundation, which can lead to foundation/structural movement. Recommend a qualified contractor adjust downspout extensions to drain at least 6 feet from the foundation.

Correctly installed gutter downspouts that are diverting the water away from the foundation.

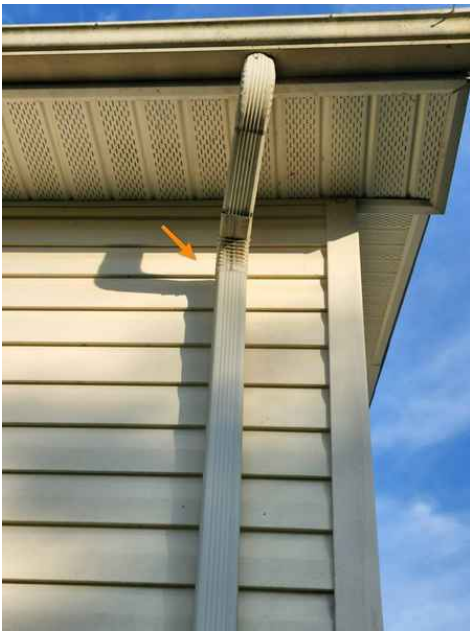
2.2.2 Roof Drainage Systems

GUTTER LOOSE

REAR RIGHT SIDE

The gutter(s) is loose and needs to be re-fastened to exterior wall and pitched properly. Loose gutters can enable moisture to get behind the gutters and cause moisture damage to the fascia and soffits.

Downspout is missing strap near the eave which has allowed the downspout to move from its proper location.

I recommend repair by a qualified gutter contractor.

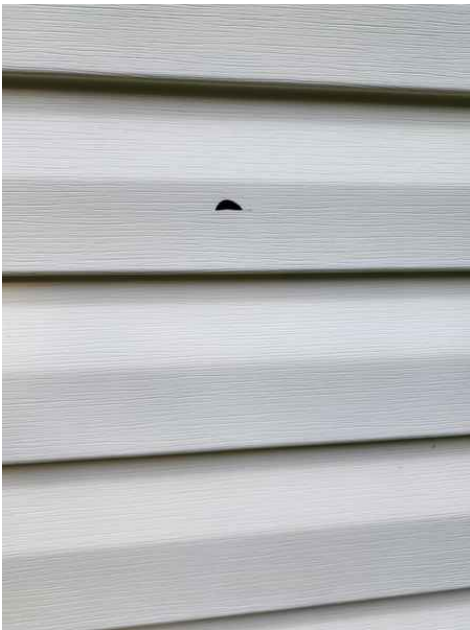
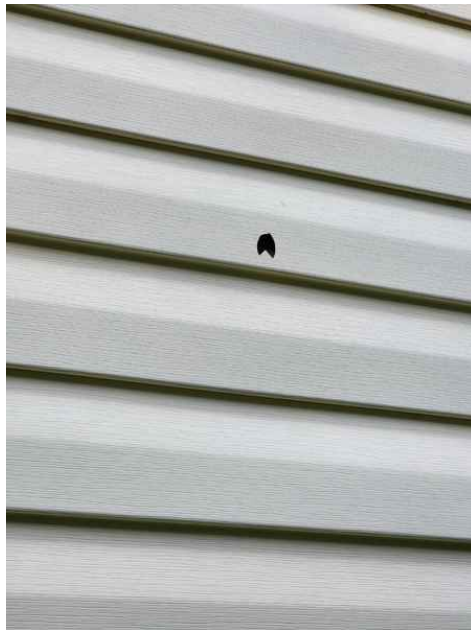
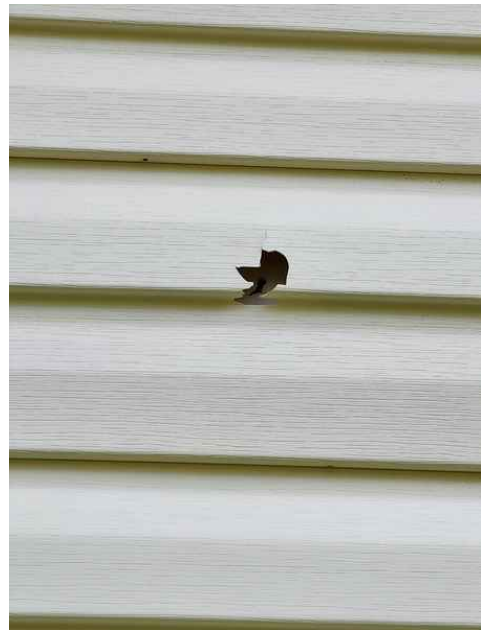
3.1.1 Siding, Flashing & Trim **SIDING DAMAGED**

Siding had several punctures possibly caused by hail or other external forces. Holes in the siding can allow moisture intrusion to reach the wall sheathing.

Recommendation
Contact a qualified professional.

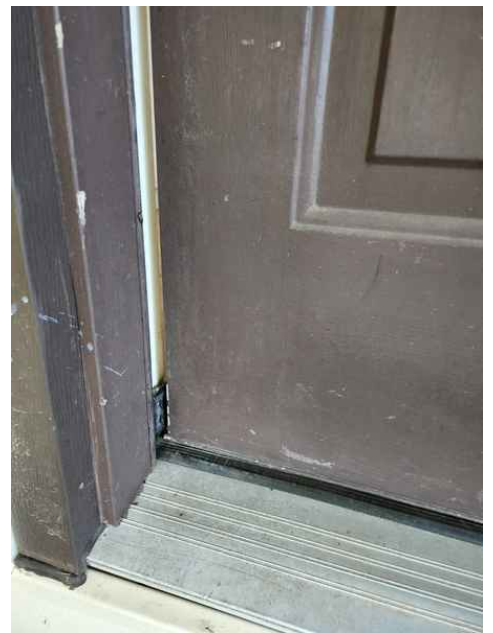
3.2.1 Exterior Doors **DOOR STICKS WHEN OPENING OR CLOSING** CARPORT DOOR

Sticking doors can be caused by thermal expansion or contraction, warper or damaged door frames, or damaged hinges. This could possibly be a safety hazard if door needed to be opened quickly. I recommend further observation by a qualified contractor.

Door at carport sticks when opening or closing

Recommendation
Contact a qualified professional.

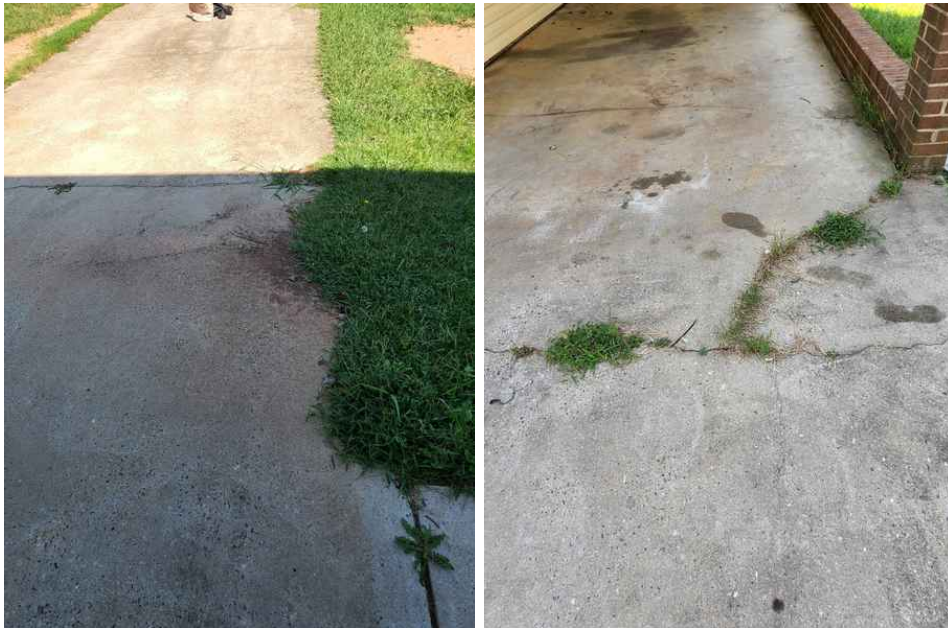
3.3.1 Walkways, Patios & Driveways **DRIVEWAY CRACKING - MINOR**

DRIVEWAY

Minor cosmetic cracks observed, which may indicate movement in the soil. Recommend monitor and/or have concrete contractor patch/seal.

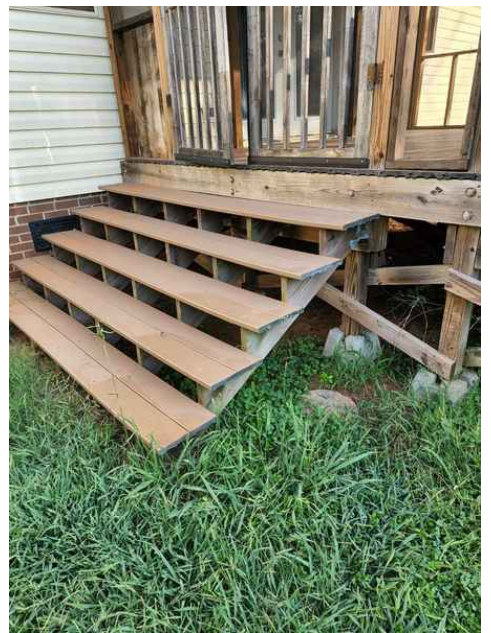
3.4.1 Decks, Balconies, Porches & Steps

STAIRS- NO HANDRAIL

REAR OF HOUSE

Any stairway with four or more risers should have a handrail on at least one side. The handrail should be at least 34 inches high. A handrail should be considered to prevent falls from the stairway. This is a safety concern.

Contact a qualified carpenter.

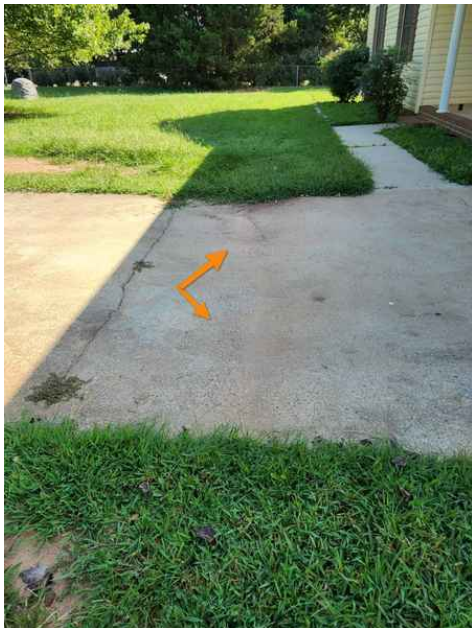
3.6.1 Vegetation, Grading, Drainage & Retaining Walls

STANDING WATER

DRIVEWAY

Evidence of standing water observed, which could indicate poor drainage and/or grading. Recommend monitor and/or have landscaper correct.

Low grade area of driveway

Contact a qualified landscaping contractor

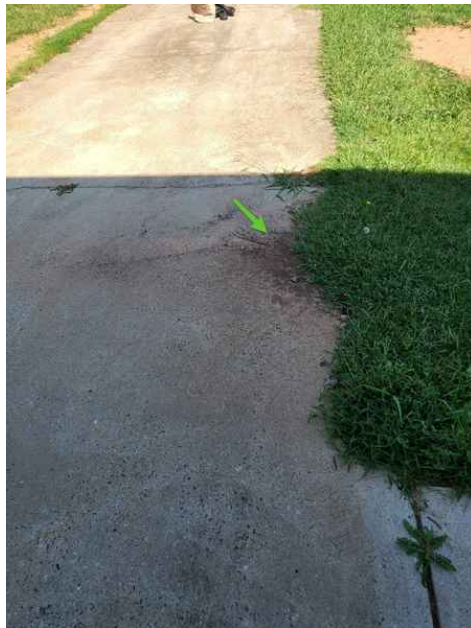
Area where water has pooled in low area of driveway

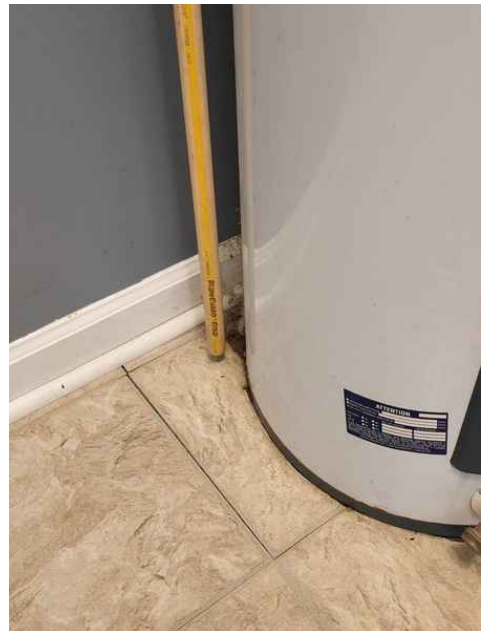
7.3.1 Water Supply, Distribution Systems & Fixtures

DRIP PAN MISSING AT WATER HEATER

LAUNDRY ROOM

Drip pan is missing from water heater. If the water heater developed a leak, water damage could occur on the floor structure and surrounding walls. Recommend having a drip pan installed by a qualified contractor.

No Drip Pan at water heater

Recommendation
Contact a qualified professional.

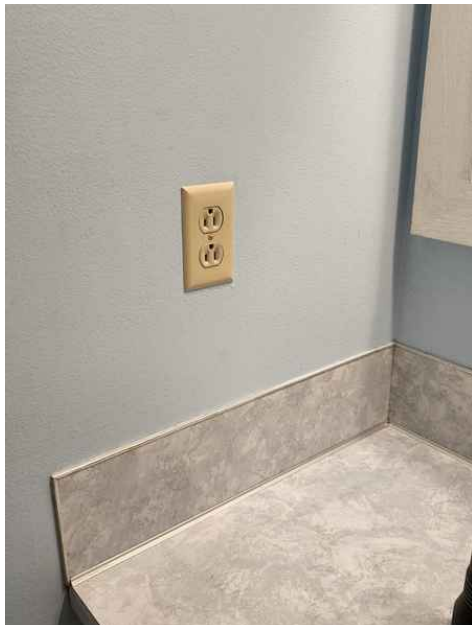
8.5.1 GFCI & AFCI

NO GFCI PROTECTION INSTALLED

No GFCI protection present in bathroom locations. Recommend licensed electrician upgrade by installing ground fault receptacles in all locations that are within six feet of a water source. This can be an electrical shock hazard.

No GFCI protection on receptacle in hall bathroom

Contact a qualified electrical contractor.

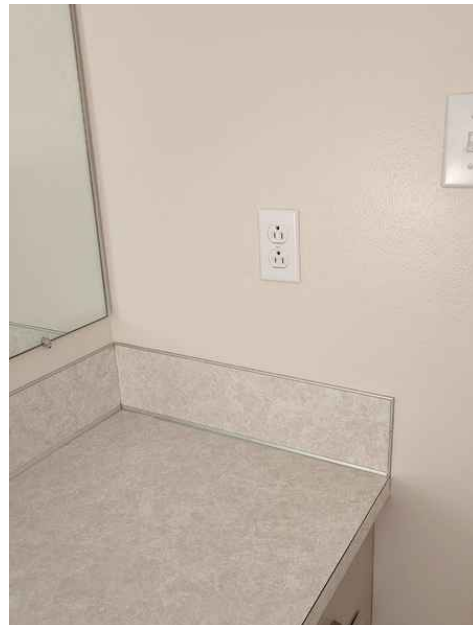
No GFCI protection on receptacle in master bathroom

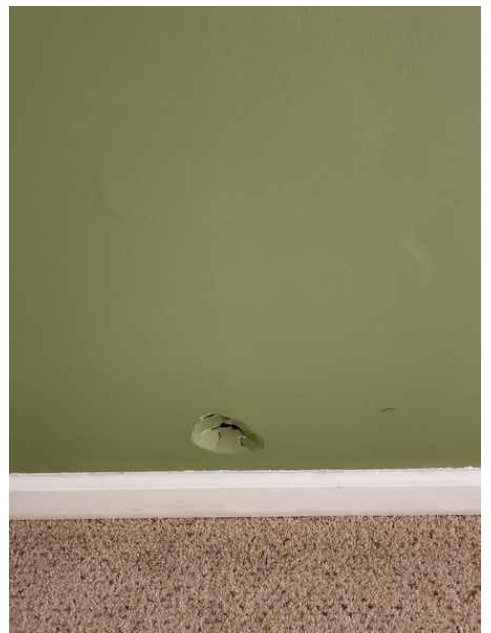
11.4.1 Walls

HOLE IN DRYWALL

BEDROOM

A hole was observed in the drywall of the rear bedroom. Recommend a qualified drywall contractor for repair.

Damaged Drywall

Recommendation
Contact a qualified professional.

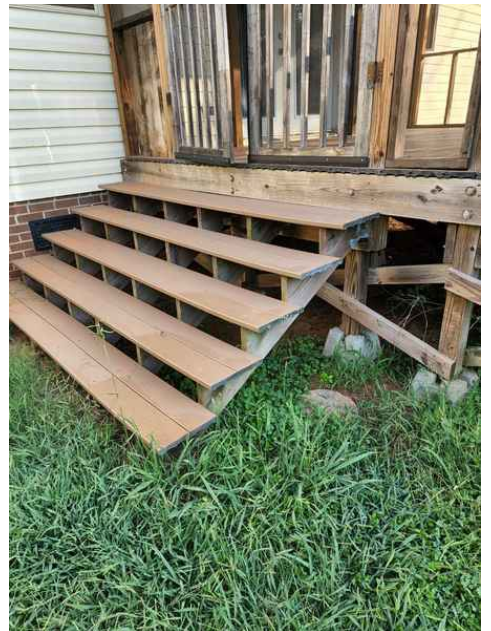
11.6.1 Steps, Stairways & Railings

NO HANDRAIL

DECK

Stairway on deck had no handrails. This is a safety hazard. Recommend a qualified handyman install a handrail.

Recommendation
Contact a qualified carpenter.
